PEACE OF MIND INSPECTIONS

RESIDENTIAL INSPECTION

16930 N 280 Rd
Morris, OK 74445

Brent Wellings
NOVEMBER 30, 2023

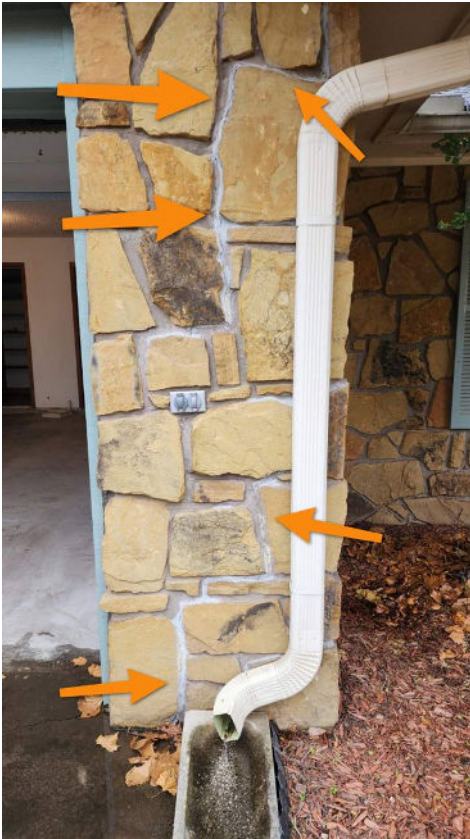
Right side of garage

MORTAR CRACKING DETERIORATING

Deteriorated or cracked mortar joints were noted in one or more areas of the brick veneer or stone siding transition. This is common over time and is typically the result of long term settlement. Recommend removal and point and tucking the mortar in these areas.

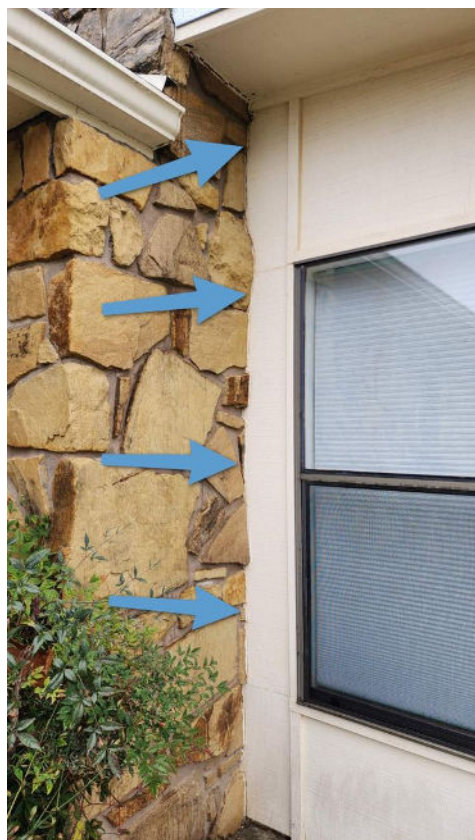
Siding transition

3.2.2 Siding, Flashing, Trim, Soffit, & Facias
CAULKING SUBSTANDARD/MISSING
 SUNROOM SIDING TRANSITION

Routine Maintenance: At the time of inspection, caulk was missing, deteriorated or substandard in some areas, like around windows or doors, at siding butt joints, at siding-trim junctions, or at wall penetrations. The Inspector recommends that the affected area(s) re-caulked by a professional contractor.

Contact a handyman or DIY project

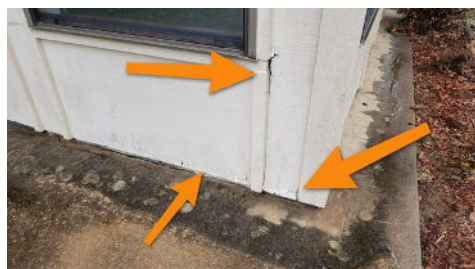
Sun room siding

WOOD ROT - EXTERIOR

Area(s) of wood rot were noted on the exterior trim, siding or other areas on the exterior of the home. The Inspector recommends that the affected area(s) be replaced, patched, painted or sealed by a licensed contractor to avoid further deterioration and possible moisture intrusion.

Contact a qualified general contractor.

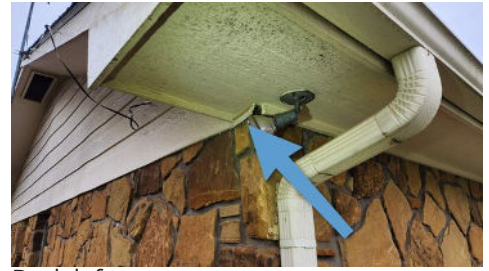
Back left corner

LOOSE/MISSING TRIM

Trim was noted as loose/missing or damaged in one or more areas at the time of the inspection. Recommend having trim installed where missing or wjere loose, secured and properly sealed to ensure water tightness and minimize insect intrusion.

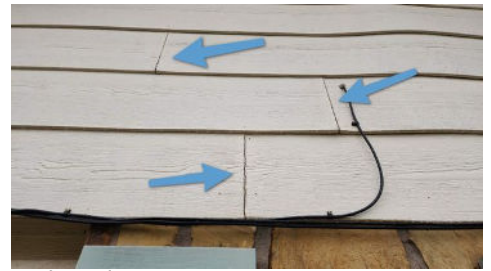
Right side

We noted gaps in siding planks in one of more locations. This is common and typically occurs as the home settles, shifts and moves over time. These gaps should be caulked/painted to avoid moisture intrusion behind the siding.

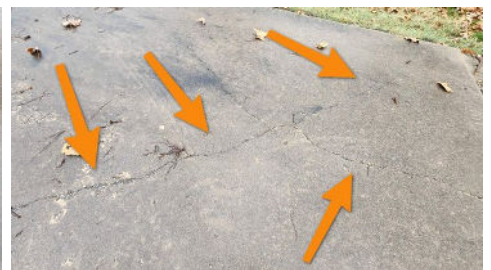
DRIVEWAY/WALKWAY CRACKING - MODERATE

Moderate cracks were observed in the driveway or walkway at the time of the inspection. This is common in aged concrete and often due to movement in the soil. Recommend concrete contractor evaluate and repair as needed. At a minimum and if possible, the cracks should be sealed with an exterior grade sealant to prevent moisture from worsening the condition.

Driveway cracks

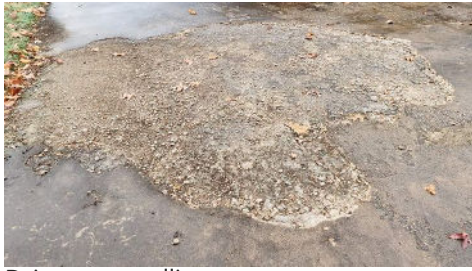
SPALLING NOTED

Areas of spalling were noted in the front driveway/walkway. Spalling can be caused by Improper curing / poor finishing techniques, Bond failure in two-course construction, Electrochemical reactions (such as from de-icing salts) Corrosion/oxidization of reinforcing rebar (due to water exposure). While this process takes place over a long period of time, these areas will continue to worsen over time if not properly patched/repared. Recommend correction as needed.

Driveway spalling

Contact a qualified concrete contractor.

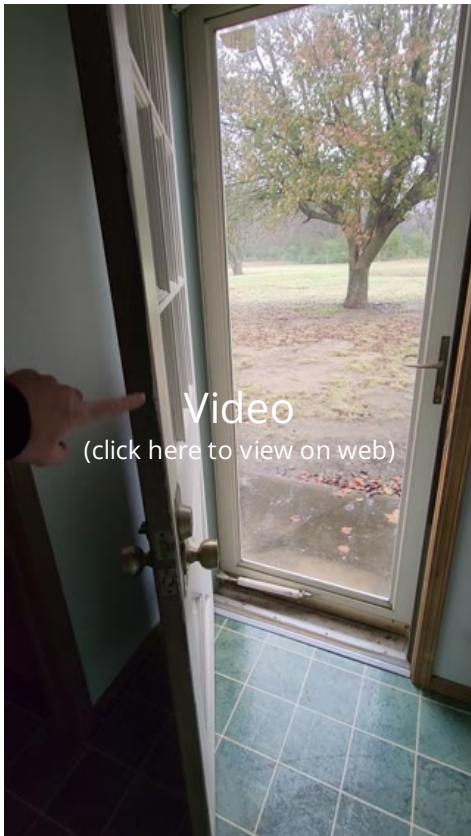
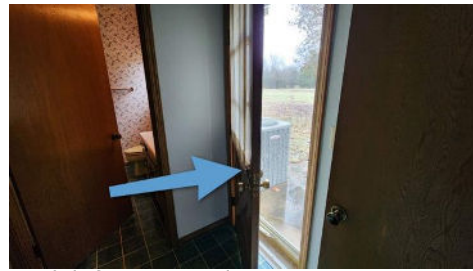
Back left exterior door

One or more exterior doors would not stay open on it's own. This is caused by the door not being hung plumb or falling out of plum over time. A simple fix is to remove the door hinge pin and hammer it on a concrete surface a few times to add a slight bend to the door pin. Reinstall the door pin. This slight bend will cause a minor bit of friction in the hinge, allowing the door to stay open. If this does not work with one hinge, keep trying on all 2-3 hinges till door stays open.

Contact a qualified general contractor.

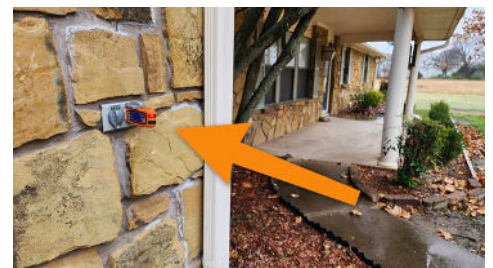
Right side of garage

One or more outlets were found with an open ground. This can cause an electrical surge to the plugged in appliance resulting in damage or electrical shock. The inspector recommends having these outlets replaced with GFCI outlets for safety purposes.

Contact a qualified electrical contractor.

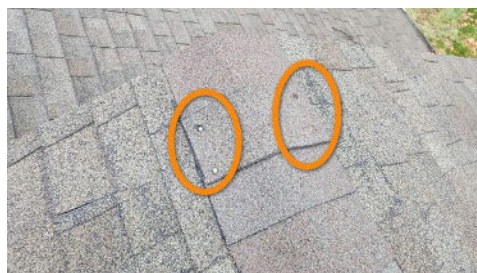
Shingle fasteners need sealed

Contact a qualified roofing professional.

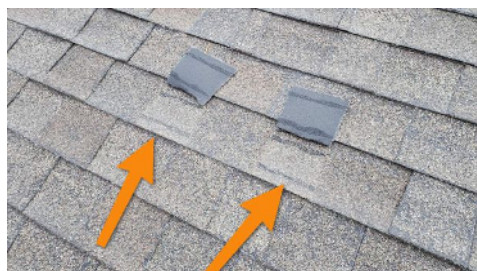
SHINGLES HAVE WIND/STORM DAMAGE

Wind damage

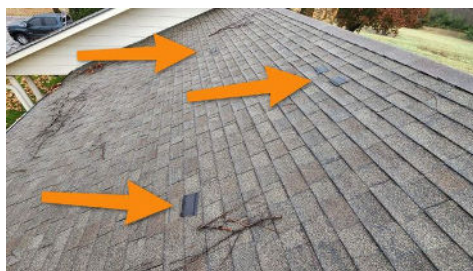
Several locations noted

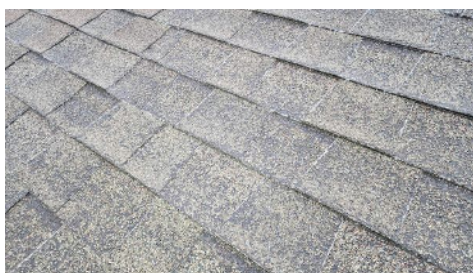
Excessive aging

Contact a qualified roofing professional.

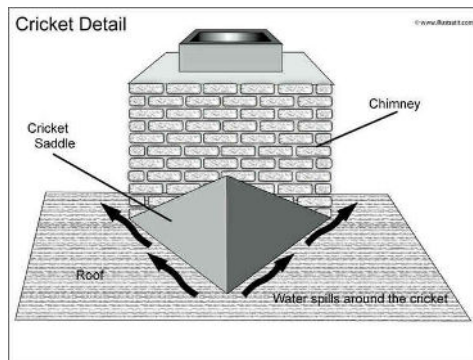
Recommend build up to divert water

Contact a qualified roofing professional.

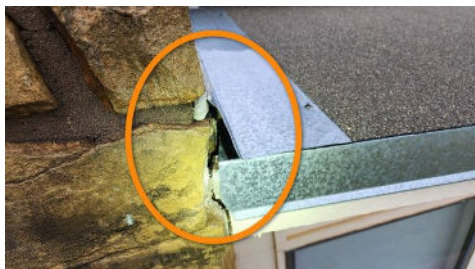
Gap in flashing

Contact a qualified roofing professional.

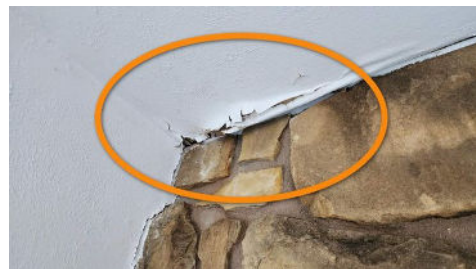
Moisture damage below this area

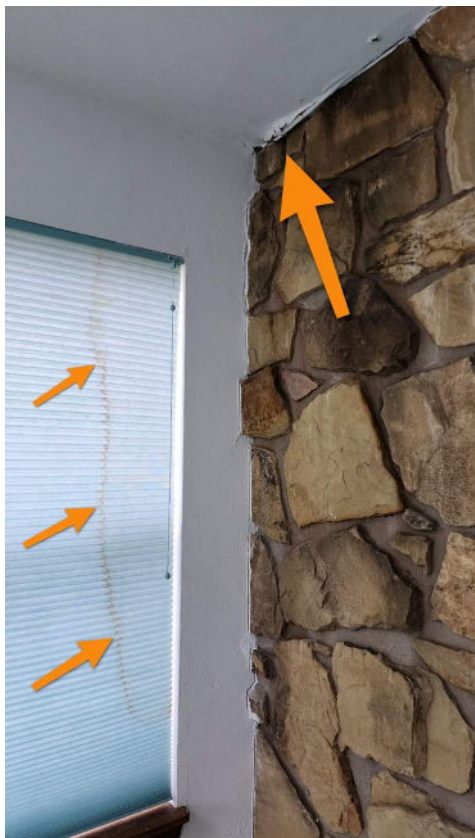
Evidence of moisture below gap

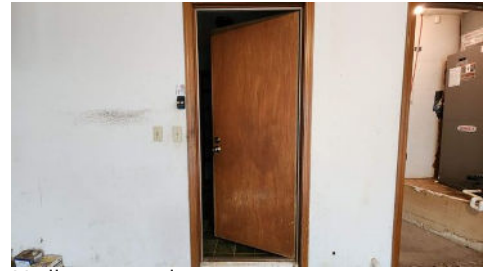
Hollow core door

Contact a qualified general contractor.

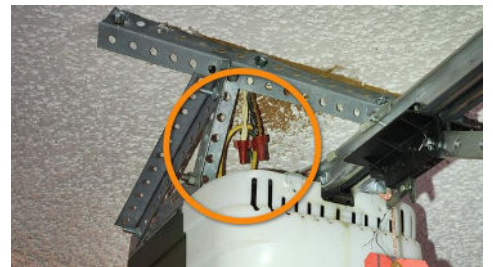
Garage door opener wiring

Contact a qualified electrical contractor.

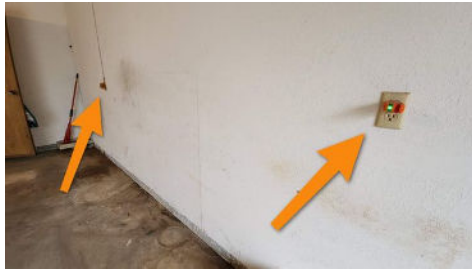
Needs gfc protection

Contact a qualified electrical contractor.

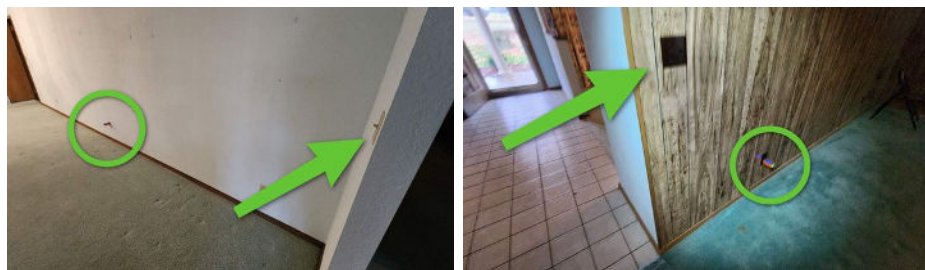
Front living room

We noted an outlet that was controlled by a light switch by the front door. This was common in homes built in this time period. The living room doesn't have a ceiling light fixture installed so the switch would be used to operate a lamp that is plugged into the outlet it controls.

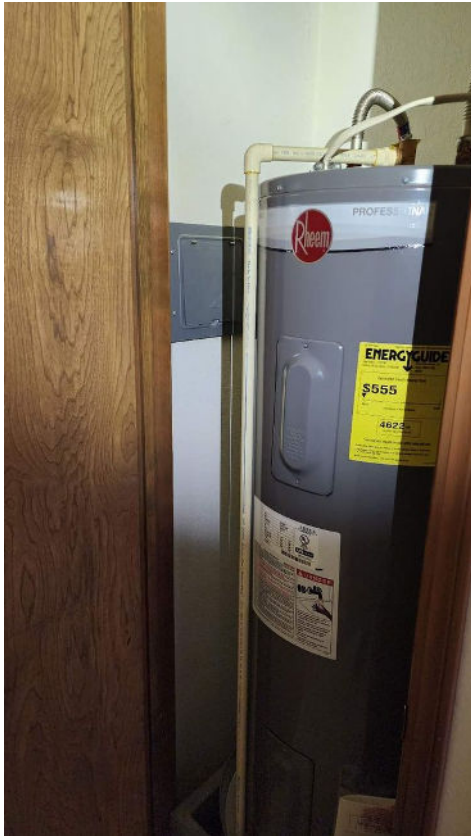
We noted a In a electrical panel that did not have adequate work space clearance. Standards require a clear area for access and working in front of an electric panel at least 36 inches in depth. The work space shall not be less than 30 inches wide in front of the electrical equipment and not less than the width of the equipment. For this reason, the panel cover could not be safely removed. No comments can be made to the interior condition of this panel.

Inadequate work space clearance

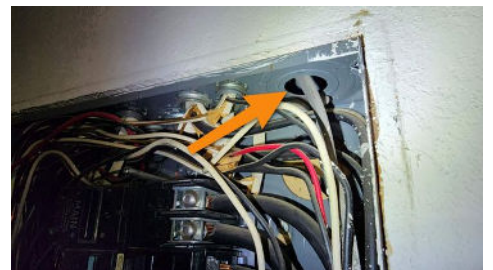
Missing bushing

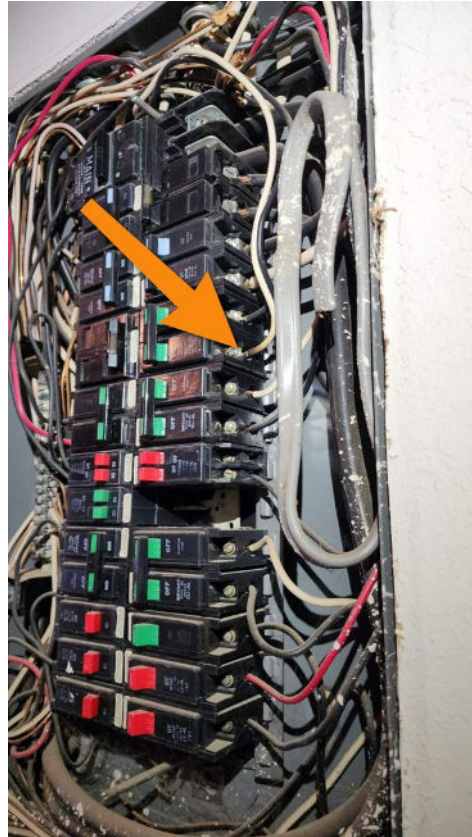
Heat damage noted

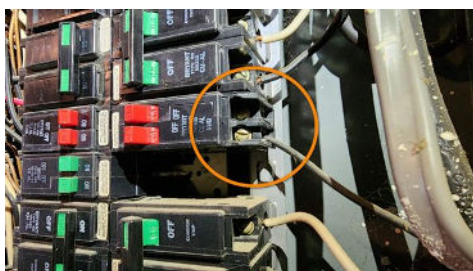
Single wire/double pole

Contact a qualified electrical contractor.

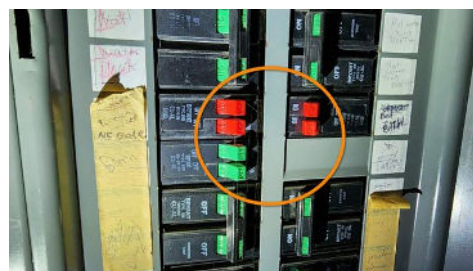
Missing handle ties

Contact a qualified electrical contractor.

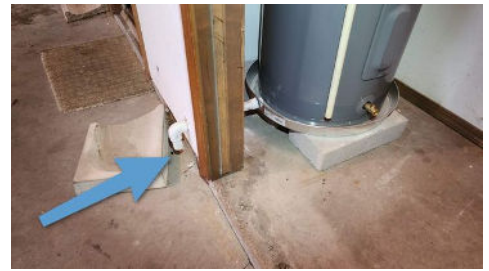
The water heater had a safety pan installed underneath which had a drain pipe coming off the pan. This pipe should be plumbed to drain in an area that will not cause moisture damage to the home, personal belongings or cause excessive moisture under the home. For example, plumbed into to primary drain. As it sits, of the water heater were to leak or discharge, water would simply flow into the crawlspace. We recommend having this line plumbed to drain properly per standard building practices.

Improper termination

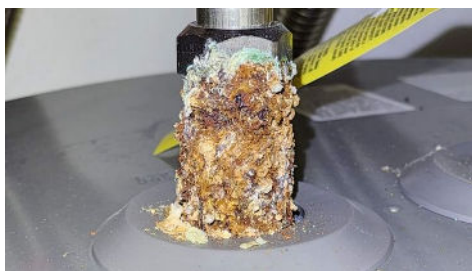
Heavy corrosion noted

Contact a qualified plumbing contractor.

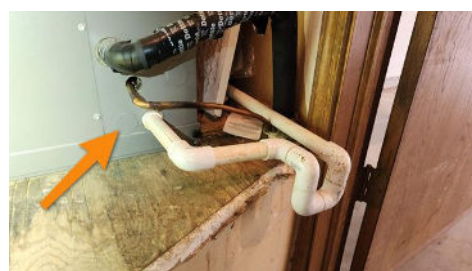
Recommend float switch installed here

We noted a furnace that did not have a secondary condensate drain or float switch installed. Secondary drain lines are designed to help prevent damage to the home in case of overflow from the primary drain pan or blockage of the primary condensate tube. Float or wet switches are designed to shut the system down in the event that it detects moisture. As it sits, if the primary drain were to clog, condensation would simply leak out of the evaporator coil cabinet causing damage to the unit and possibly the surrounding areas of the home. We recommend that a secondary drain system of an approved type be installed. Another option is to have a float switch installed that would shut down the system in the event of a primary line clog. With older units that do not have a secondary condensate port available, float switches can be installed on a single condensate drain line configuration.

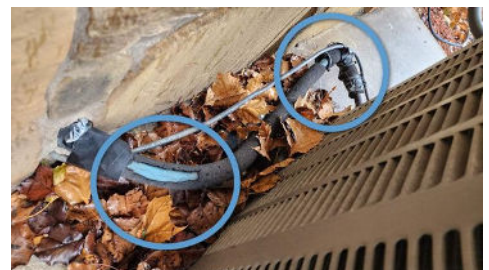
We noted missing, damaged or deteriorated insulation on one or more sections of the condensing units suction line on one or more sections. This can cause energy loss and produce condensation. Recommend having the entire line checked for voids then repaired/replaced to ensure proper efficiency.

Line insulation deteriorated

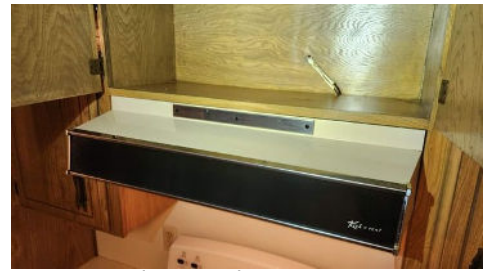
NOT VENTED PROPERLY

Not vented properly

Contact a qualified appliance repair professional.

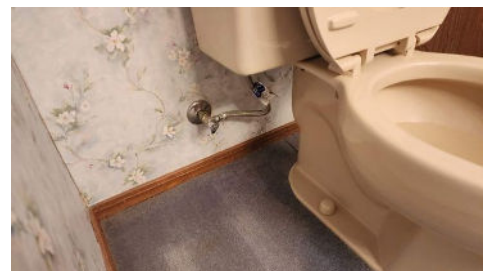
TOILET VALVE IN OFF POSITION

At the time of the inspection, one or more toilets shut off valves were in the off position. Since the inspector is unaware of why this valve is off and the possibility of leaks, we do not operate shut off valves. This creates a limitation for toilet inspections.

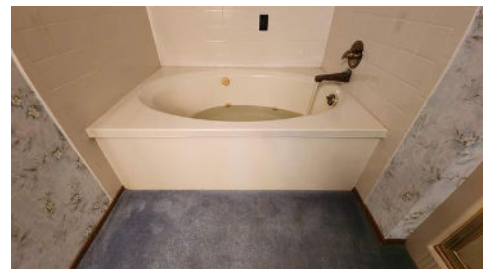
JETTED TUB ACCESS SEALED

At the time of the inspection, there was no visible access to the jetted tubs pump or plumbing components or the access could not be removed. This creates a limitation for the inspector in checking for leaks. Recommend that an access point be installed or existing panels be made accessible for service and maintenance.

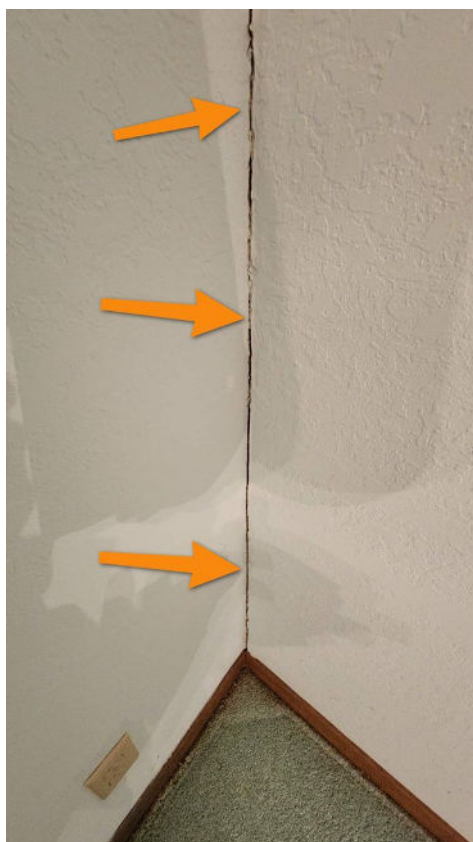
Corner seam crack

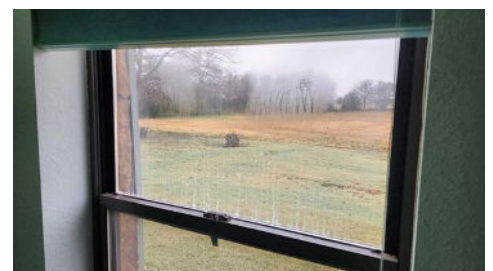
Front right bedroom

We observed condensation between the window panes of one or more windows in the home which indicates a failed seal. Faint fogging or condensate can indicate early stages of failing. This can impact energy efficiency. Recommend qualified window contractor evaluate & replace as needed.

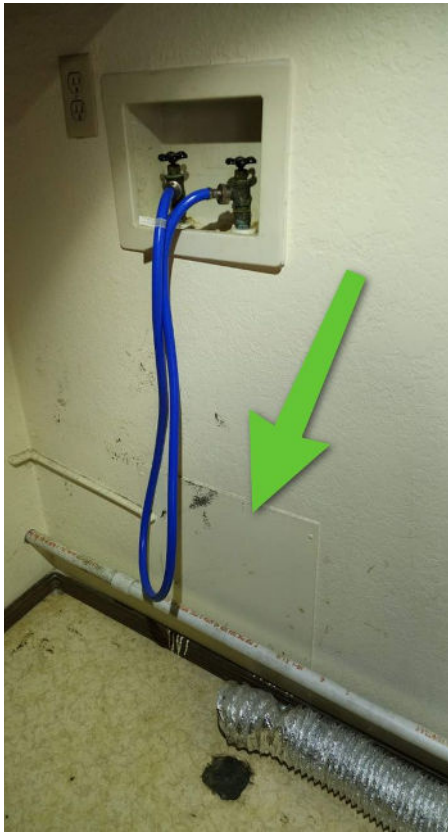
We noted evidence of previous repairs underneath the washer box in the laundry room. Although no moisture was present, these repairs are typically the result of a previous water leak. We recommend consulting the seller around the nature of these repairs. No comments can be made to the conditions of the wall structure on the other side of these repairs. Evaluation of the area would require removing the drywall patch if falls outside the scope of a limited, visual home inspection.

Below washer connections

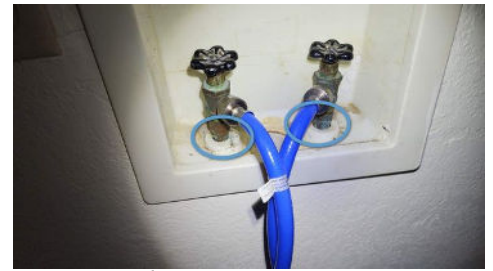
Missing seals

Contact a qualified plumbing contractor.

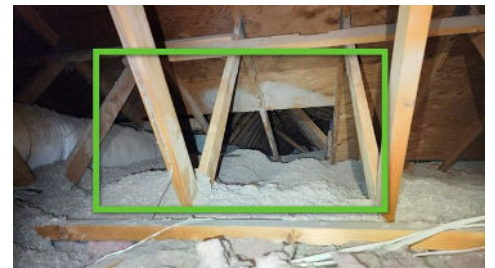
The attic inspection was limited due to the lack of adequate head room due to framing or roof pitch, return and supply air ductwork and little to no floored surfaces. This makes it difficult and unsafe to navigate the entire attic space. This report refers to visible and accessible areas of the attic only. No comments can be made to the areas that are not accessible.

No access beyond this point
