PEACE OF MIND INSPECTIONS

RESIDENTIAL INSPECTION

16930 N 280 Rd
Morris, OK 74445

Brent Wellings
NOVEMBER 30, 2023

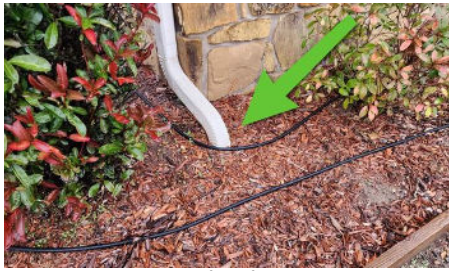
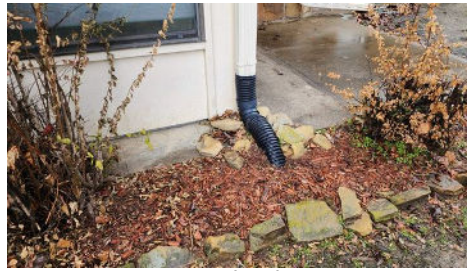
French drains noted

FYI: We noted french drains in the yard and or gutter system at time of inspection. We are unable to fully inspect these as they are under ground and not fully accessible. Recommend monitoring during rain storms or running a garden hose through them to ensure proper drainage.

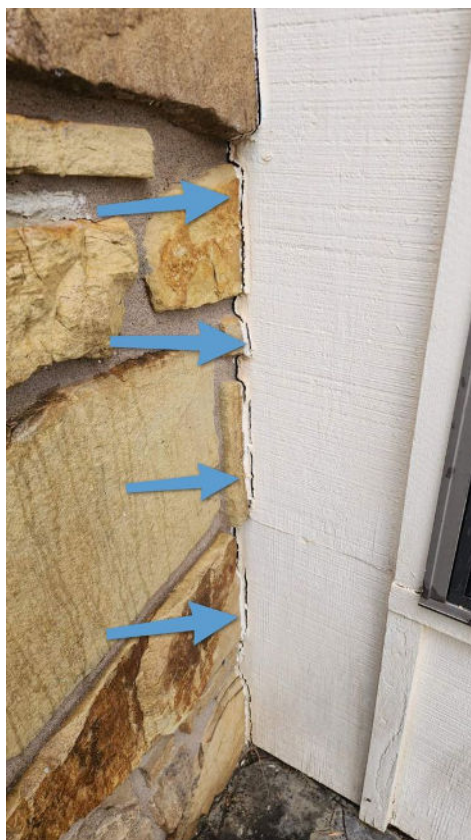
Pulled caulking

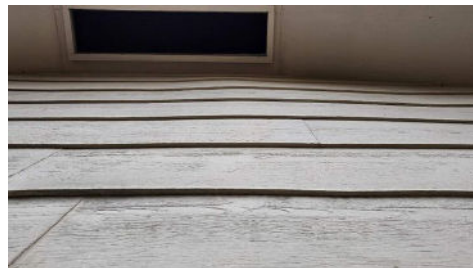
Bowed/warped

Contact a qualified siding specialist.

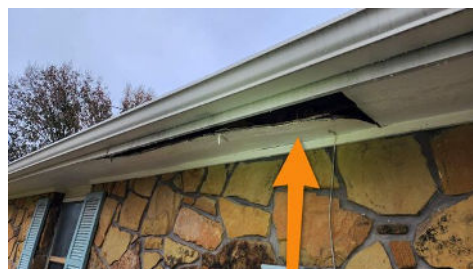
Soffit sagging

Contact a qualified general contractor.

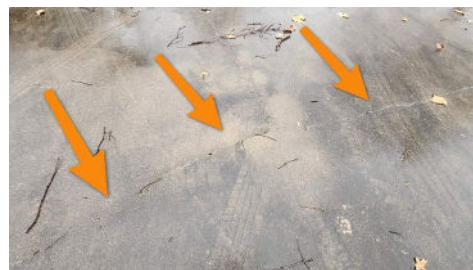
Driveway cracks

Contact a qualified concrete contractor.

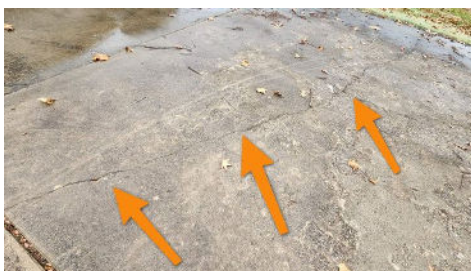
Driveway cracks

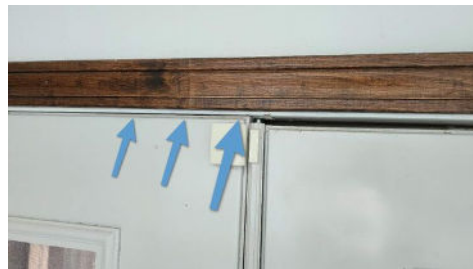
Binding at top

Contact a qualified general contractor.

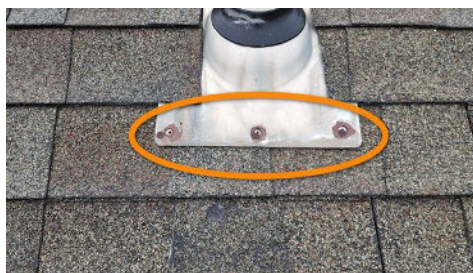
Flashing fasteners need sealed

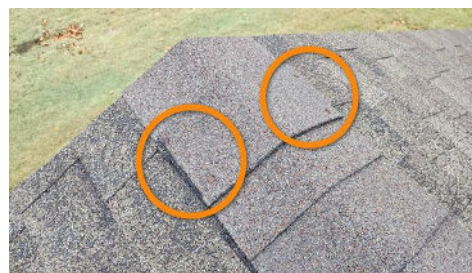
Shingle fasteners need sealed

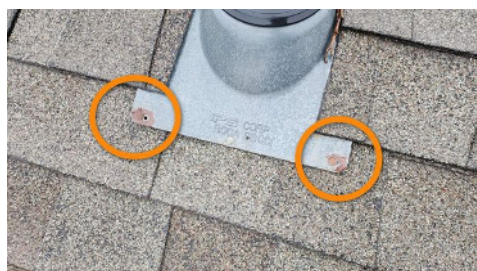
Flashing fasteners need sealed

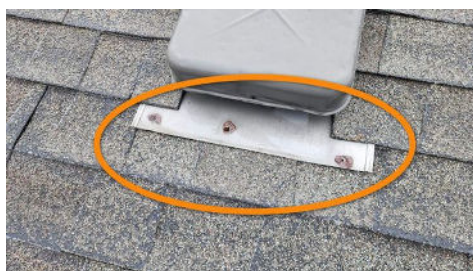
Fasteners need sealed

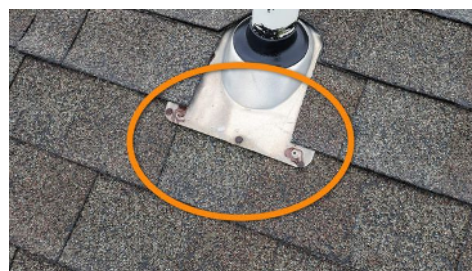
Flashing fasteners need sealed

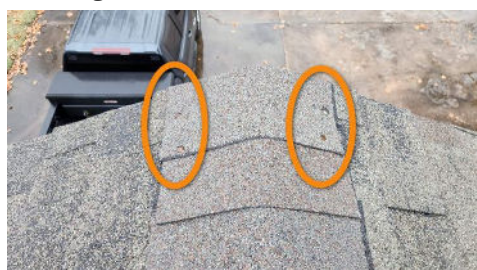
Shingle fasteners need sealed

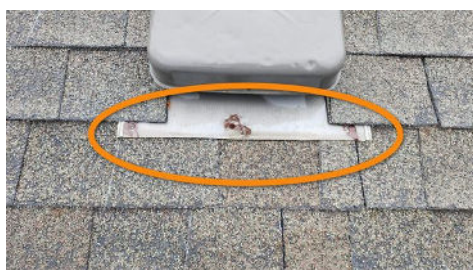
Flashing fasteners need sealed

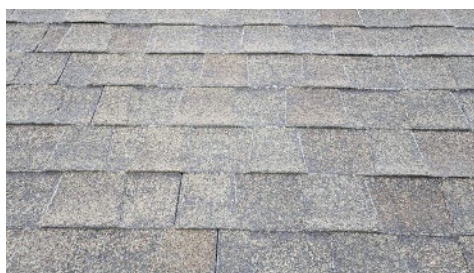
The roof in it's current condition, showed excessive signs of aging including but not limited to: Granual loss, craze cracking, significant or excessive wear and tear, hail, or displayed areas in need repairs.

Significant granular loss

The inspector recommends having the roof further evaluated by a licensed roofing contractor.

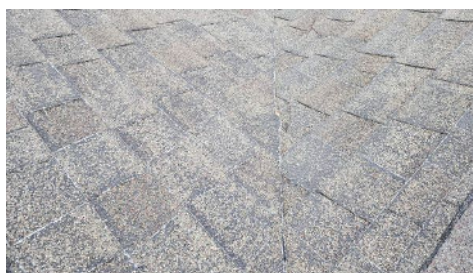
Aging roof

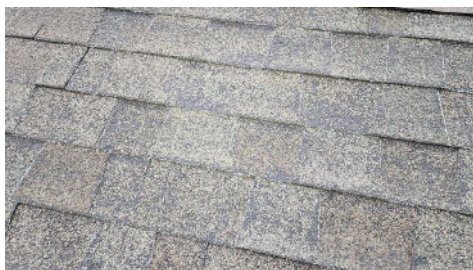
Example photo

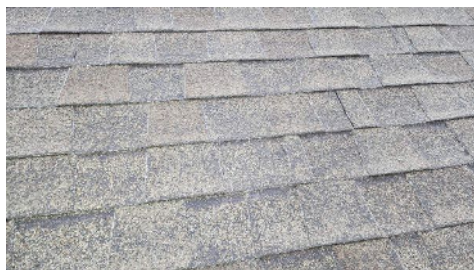
Aging roof

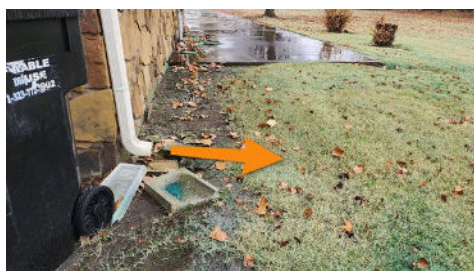
Left side

One or more downspouts drain too close to the home's foundation. This can result in excessive moisture in the soil at the foundation, which can lead to foundation/structural movement. Recommend a qualified contractor install downspout extensions to drain at 3 to 4 feet from the foundation. Grading around the home should be taken into consideration when installing downspouts as it may not be necessary where the grading is adequate in directing water flow. Splash blocks are ineffective method of diverting rain water away from the foundation.

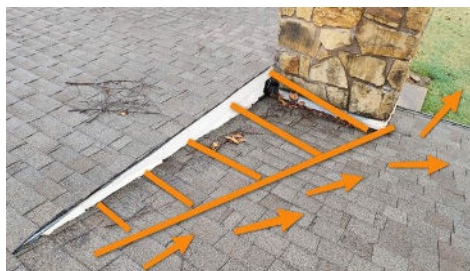
The chimney had no cricket installed. A cricket is a small section of roof built on the uphill side of a chimney to prevent rain and snowmelt from pooling and causing damage from roof leakage. Crickets are recommended for chimneys measuring 30 inches wide or more. This condition may result in premature failure of roofing in this area and/or damage to home materials or personal belongings from moisture intrusion. We recommend you consult with a professional roofing contractor to discuss options and costs for correction.

Recommend build up to divert water

Contact a qualified roofing professional.

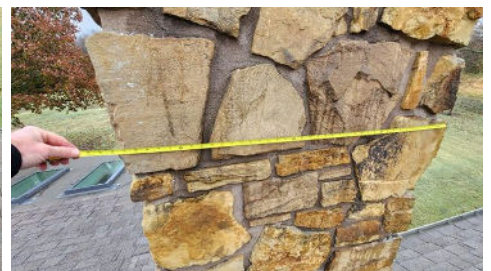
Over 30 inches

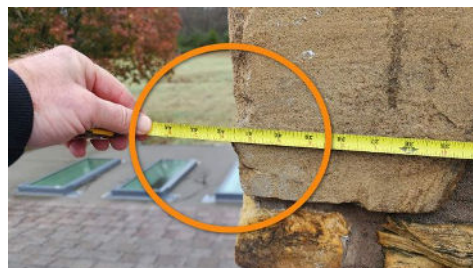
41 to 42 inches wide

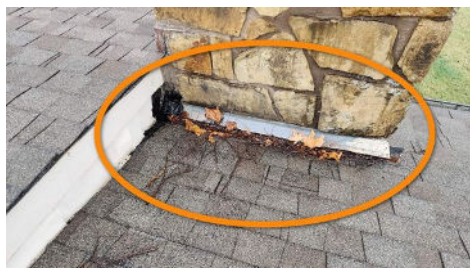
Potential snow/water accumulation

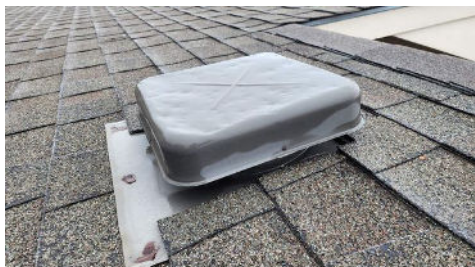
We noted hail damage to soft metals visible on roof penetrations such as combustion flues, roof vents or flashings. This is typically a clean indicator that the roof coverings have been exposed to at least minor hail at one time or another. This evidence could have occurred before the roof was last replaced as it is common for the old flues and roof vents to remain in place. None of the flues or vents appear to be damaged to the point of affecting functionality. If this is a concern, have a licensed roofing contractor further evaluate the roof coverings.

Evidence of hail

Recommend monitoring.

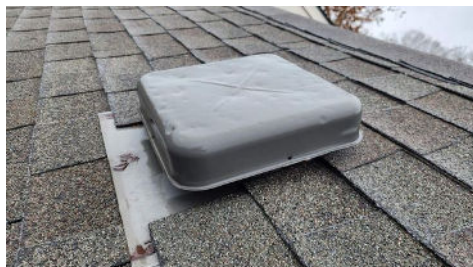
Evidence of hail

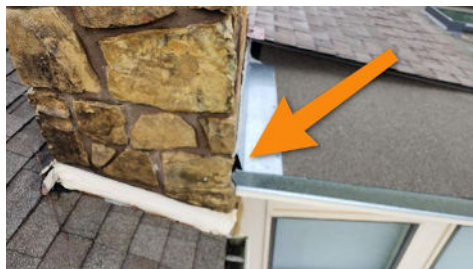
Base of chimney

We noted gaps in one or more areas of flashing that will allow moisture intrusion into the decking, attic or home. Flashings should have no gaps/voids and be installed in a way that routs water away from the flashed area. Recommend sealing this gap to minimize the possibility of moisture intrusion.

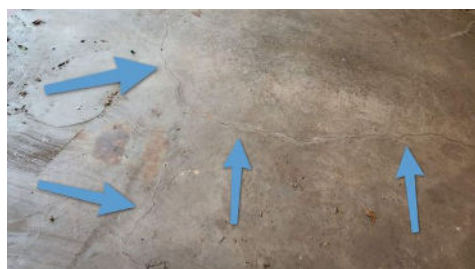
Garage floor

We observed cracks at the garage floor. These are common as concrete cures and are not structural in nature and can be sealed as needed with exterior grade concrete sealant. Movement in the soil can also be contributing factor in older or aged concrete in certain cases. Recommend sealing and monitoring going forward.

Recommend monitoring.

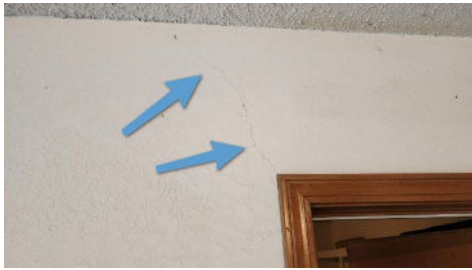
Left wall

Settlement cracking, drywall seam cracking of other evidence of settlement was noted in one or more areas of the garage. These can be attributed to long term settlement of the home. Recommend having repaired as needed.

Contact a qualified drywall contractor.

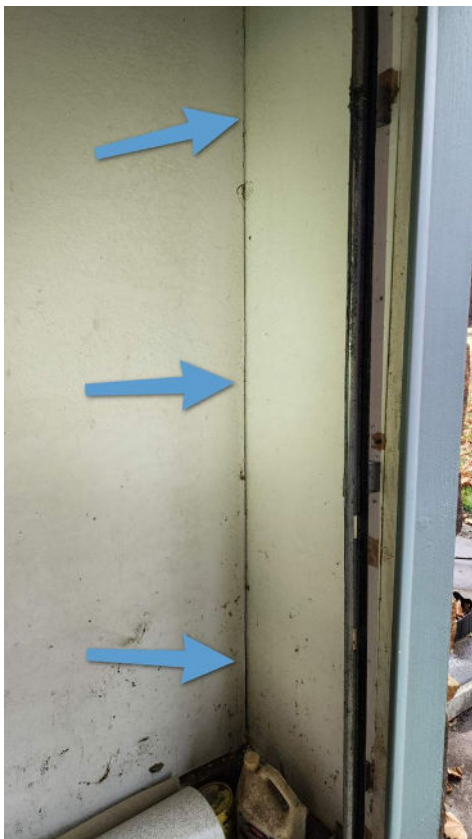
Seam separation

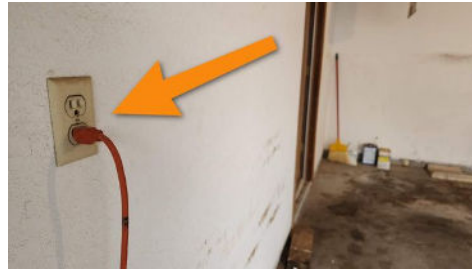
Left wall

RECOMMENDATION: GFCI Protection was missing at one or more outlets in the garage. This may not have been a requirement when this home was built or, these outlets may be downstream from a defective gfci. If not downstream, recommend replacement of standard outlets with GFCI outlets. If these outlets are downstream from a defective gfci, have gfci replaced for safety reasons and to comply with modern standards.

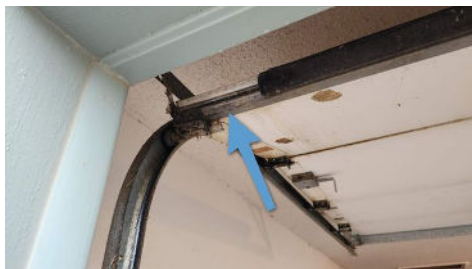
The garage door weather seal that runs along the bottom of the garage door was damaged or otherwise deteriorated. This sweep helps prevent moisture and vermin from entering the garage area. Wooden garage doors will absorb moisture causing rot without a proper weather seal. Recommend having repaired or replaced as needed.

Missing section

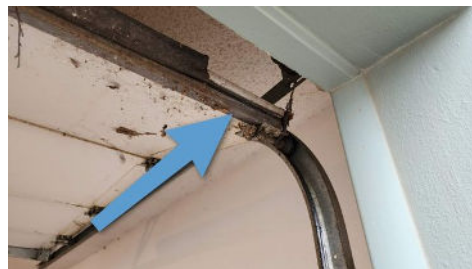
Damaged bottom seal

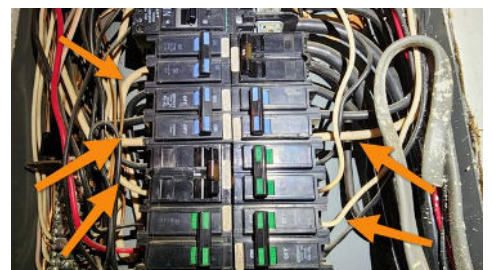
Service panel

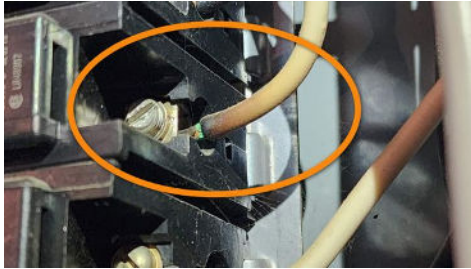
One or more areas or components of the electrical service panel displayed evidence of scorching or heat related damaged. The inspector was unable to determine when this damage took place. This condition in an electrical panel is a considerable safety concern. A licensed electrician should evaluate the panel and make necessary repairs.

Heat damage noted

Contact a qualified electrical contractor.

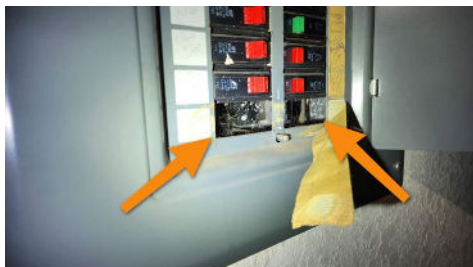
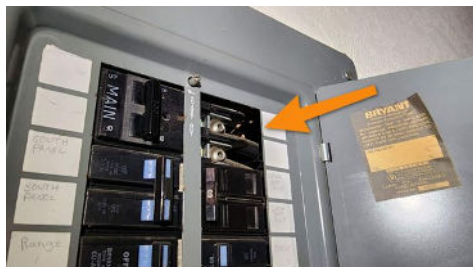
One or more slots where circuit breakers are normally installed were open in the panel. Energized equipment was exposed and can be a shock and fire hazard from lack of containment. Recommend that a licensed electrician install closure covers where missing.

Open slots

Contact a qualified electrical contractor.

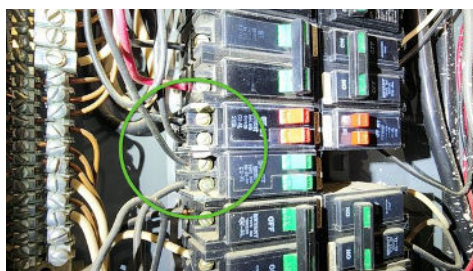
One or more double pole circuit breakers at panel(s) had only one wire connected to their terminals. Normally 2 hot wires on a circuit are used with a double pole breaker. When only 1 wire is used, and that circuit becomes overloaded, the circuit breaker may not trip. This is a potential safety hazard for fire and/or shock. A qualified electrician should repair per standard building practices.

Should look like these

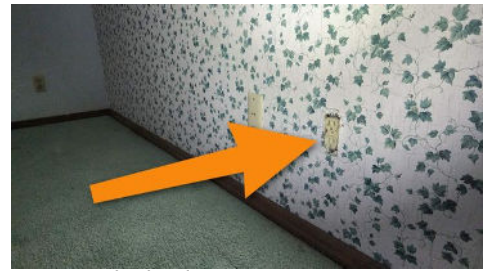
Front right bedroom

One or more outlets were missing their cover plates at the time of the inspection. Cover plates are intended to contain fire and prevent electric shock from exposed wires. This is a safety hazard due to the risk of fire and shock. Cover plates should be installed or replaced where missing. Recommend installation of plates.

Contact a handyman or DIY project

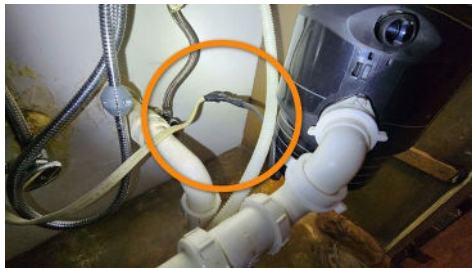
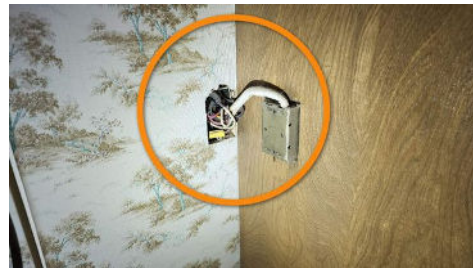
One or more wire connections were noted as improperly spliced at the time of the inspection. This is potential shock hazard. For safety fire prevention purposes, the inspector recommends junction box be installed by a licensed professional.

Disposal wiring

Behind fridge

Contact a qualified electrical contractor.

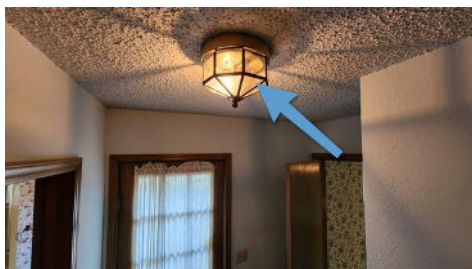
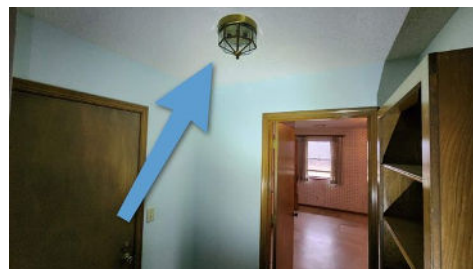
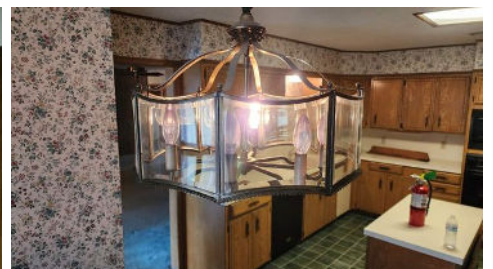
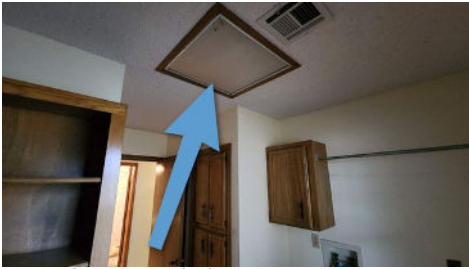
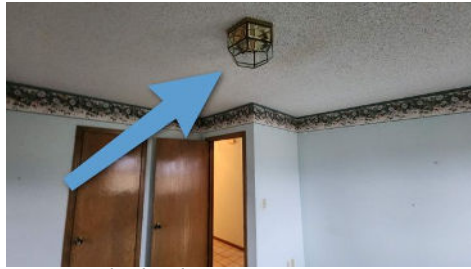
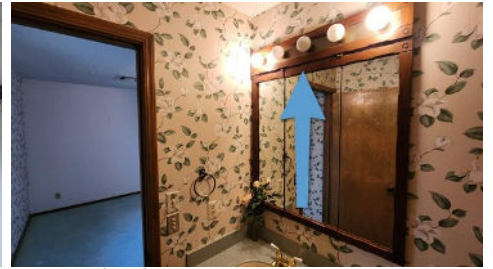
One or more light bulbs were missing or inoperable. Recommend having the bulb replaced to ensure operation before closing. If the light still does not work after replacing the bulb, consider consulting an electrician for repairs.

Contact a handyman or DIY project

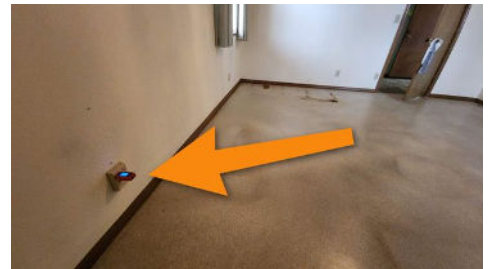
Back left bedroom

The outlet(s) pictured here did not have power at the time of the inspection. This indicates an issue with the outlet wiring or breaker. Recommend evaluation and repair by a licensed electrician.

Contact a qualified electrical contractor.

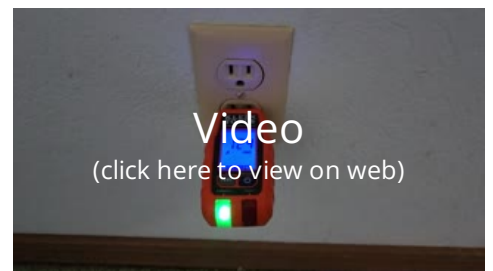
We noted loose outlets inside the wall boxes at one or more locations throughout the home. Recommend checking all outlets to ensure tightness. With loose outlets over time, wires can become loose from their lugs which poses a safety issue. While a licensed electrician is recommended, these can typically be tightened by removing cover plate and tightening upper and lower screws.

Contact a qualified electrical contractor.

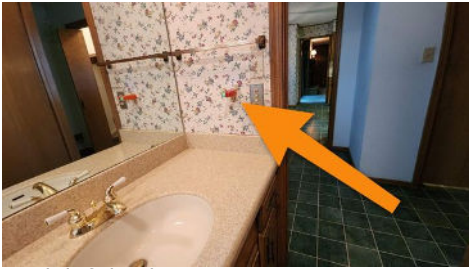
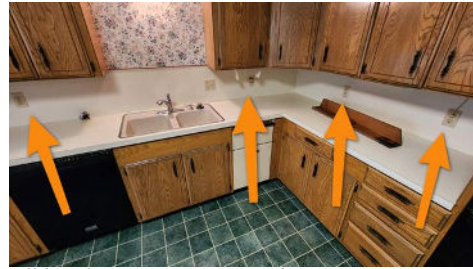
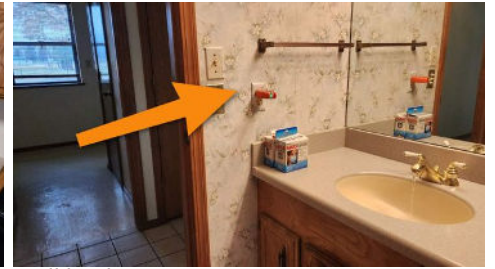
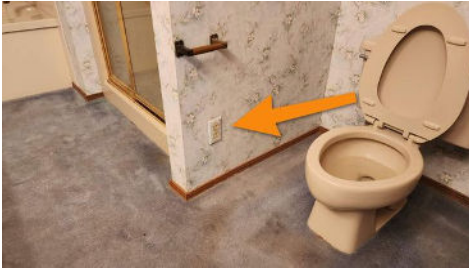
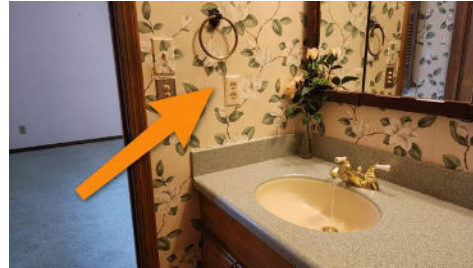
No GFCI protection was present in all the recommended locations. This may not have been a requirement when the home was built in which case it is grandfathered in to this modern standard. For safety purposes, we recommend that a licensed electrician upgrade these outlets by installing ground fault receptacles in all recommend locations (Kitchen, Bathrooms, laundry rooms, Exterior, Garage, shops, outbuildings, sheds, Crawlspace, Basements, Wet Bars, and all locations within 6 of water sources). The inspector recommends upgrading these outlets for safety purposes.

Contact a qualified electrical contractor.

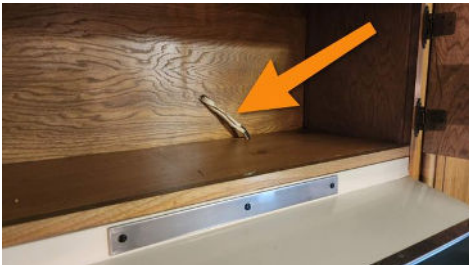
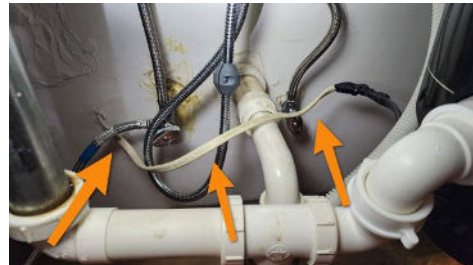
MISSING/SUBSTANDARD CONDUIT

We noted one or more areas of electrical wiring that was exposed or not properly contained within conduit and subject to damage. Wiring should be fully contained within the wall or in conduit if not. Recommend that all wiring be adequately contained inside the wall or in surface mounted conduit. All work should be completed by a licensed electrician.

Contact a qualified electrical contractor.

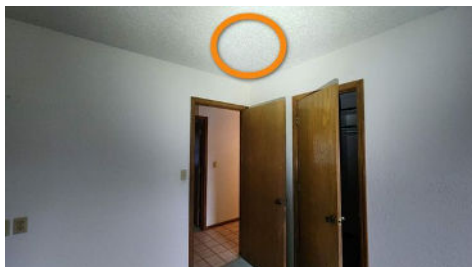
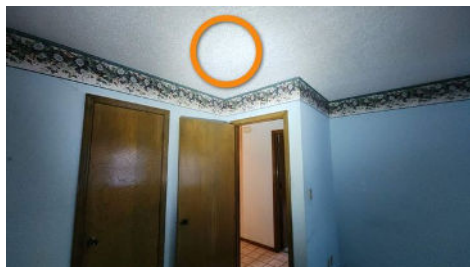
We noted smoke alarm(s) missing from one or more required locations. This is potential safety concern. Recommend having a smoke alarm installed in this room/area and verifying operation before closing.

Missing in bedrooms

Contact a qualified electrical contractor.

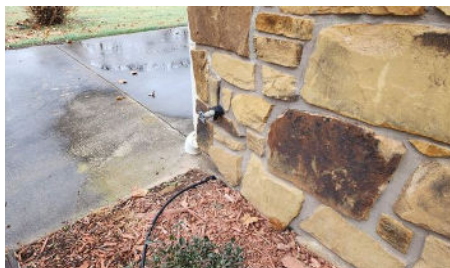
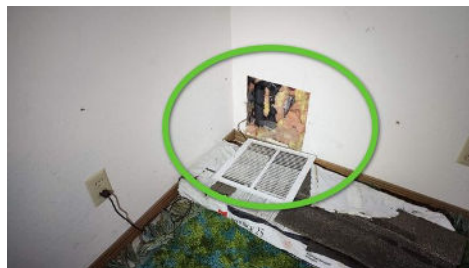
We noted evidence of previous plumbing repairs in one or more areas of the home. We recommend consulting the sellers as to the nature of these repairs.

Repairs noted on inside wall

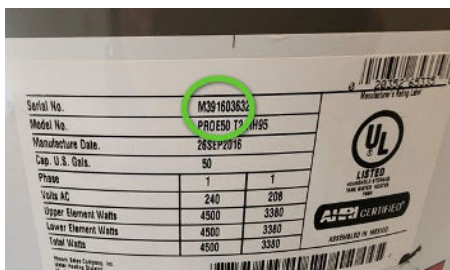
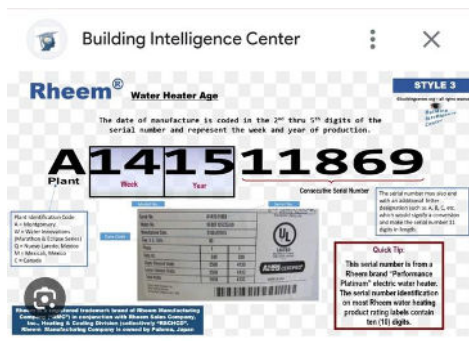
Water heaters have a typical life expectancy of 9 to 12 years. The existing unit was approximately half way or more to this age range. One cannot predict with certainty when repairs or replacement will become necessary. Regular maintenance and inspections are advised.

I recommend flushing & servicing your water heater tank annually for optimal performance. Water temperature should be set to at least 120 degrees F to kill microbes and no higher than 130 degrees F to prevent scalding.

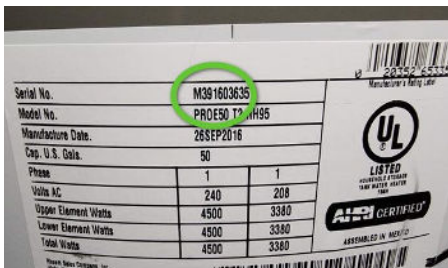
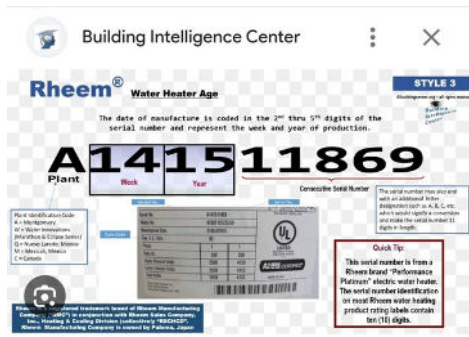
Water heaters have a typical life expectancy of 9 to 12 years. The existing unit was approximately half way or more to this age range. One cannot predict with certainty when repairs or replacement will become necessary. Regular maintenance and inspections are advised.

I recommend flushing & servicing your water heater tank annually for optimal performance. Water temperature should be set to at least 120 degrees F to kill microbes and no higher than 130 degrees F to prevent scalding.

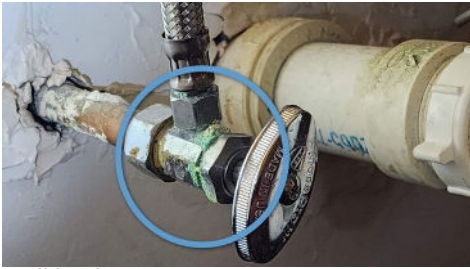
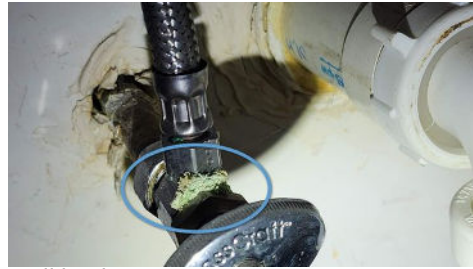
Hall bath

CORROSION ON SUPPLY FITTINGS

FEW LOCATIONS NOTED

Minor to moderate corrosion was noted on one or more water supply pipes, fittings, shut off valves and or connection points. Recommend having the corrosion removed and monitoring for leaks. Or consider replacing the fittings or valve all together to minimize the possibility for leaks.

Contact a qualified plumbing contractor.

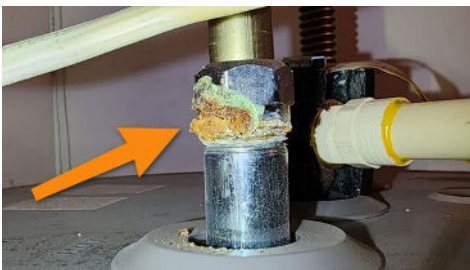
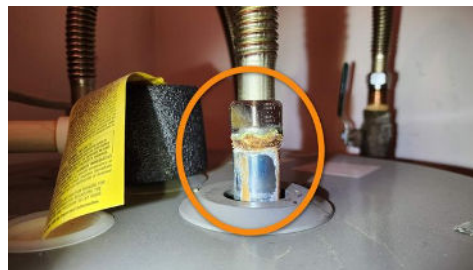
CORRODED PIPES/FITTINGS/WATER SHUT OFF

Corrosion was found at water supply pipes, water shut offs, and/or fittings. This area was not leaking however, likely will if not addressed. Recommend that a qualified plumber evaluate, clean or replace components to prevent leaks from occurring in the future.

Corrosion noted

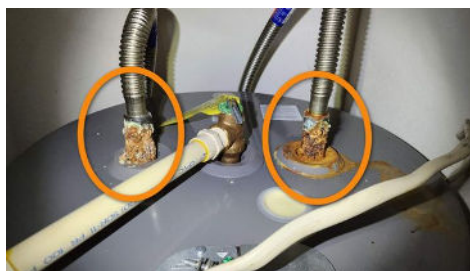
CORRODED PIPES/FITTINGS/WATER SHUT OFF

Corrosion was found at water supply pipes, water shut offs, and/or fittings. This area was not leaking however, likely will if not addressed. Recommend that a qualified plumber evaluate, clean or replace components to prevent leaks from occurring in the future.

Heavy corrosion noted

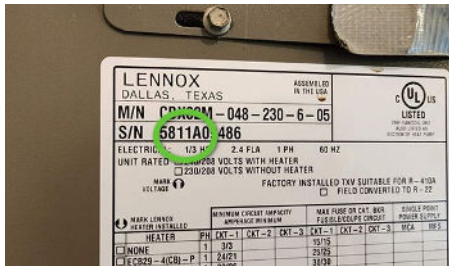
Heating Equipment: Unit Middle Aged

While the furnace was functioning at the time of the inspection, furnaces have a typical life expectancy of 18 to 20 years. The existing unit was approximately half way or more to reaching this age range. One cannot predict with certainty when considerable repairs or replacement will become necessary. Regular maintenance is advised and can significantly increase the lifespan of these units. We recommend entering into a service agreement with a local HVAC company in order to maximize life expectancy.

2011 model

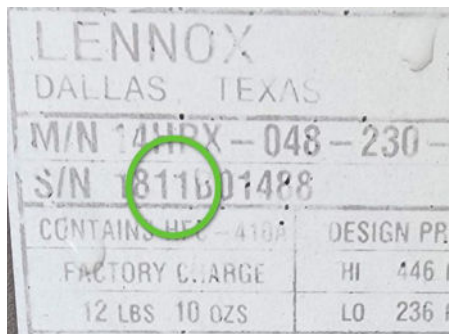
Cooling Equipment: AC Unit Middle Aged

While the AC was functioning at the time of the inspection, modern air conditioners have a typical life expectancy of 15 to 20 years. The existing unit was approx half way or more to this age range. One cannot predict with certainty when considerable repairs or replacement will become necessary. Regular maintenance and service is advised and can significantly extend the life of these units. We recommend entering into a service agreement with a local HVAC company.

2011 model

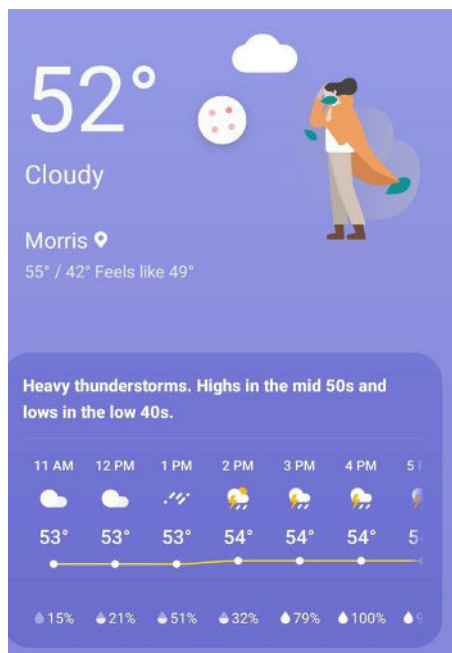
The A/C unit was not tested due to low outdoor temperature. It's true that running air conditioners in cold weather is a bad idea. Air conditioners with condensing units are not designed to be run in cool / cold weather at all. The units contain oil that is designed to lubricate the compressor, and that oil is a heavy grade that works best in warm conditions. When the weather gets cold, the oil becomes thicker, and will not lubricate the compressor properly.

Temp at time of inspection

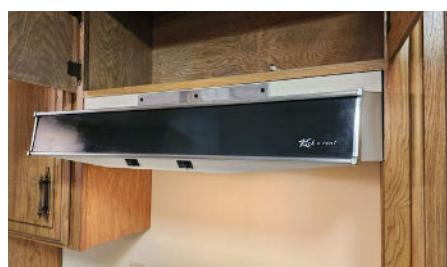
Vent hood

Not vented properly at the time of the inspection.

Since there is no vent pipe installed that would vent to the exterior, vent hoods should be set up for recirculating ventilation. However, the cover on the top front which would allow for recirculating venting was not removed. This does not allow for proper venting as the air cannot escape. Recommend having the lid/cover removed to allow for proper venting.

Contact a qualified appliance repair professional.

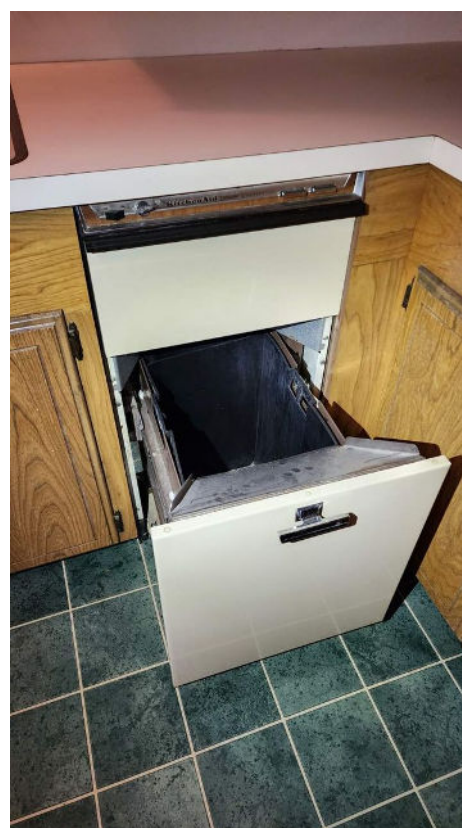
Trash compactor

Not functional at the time of the inspection.

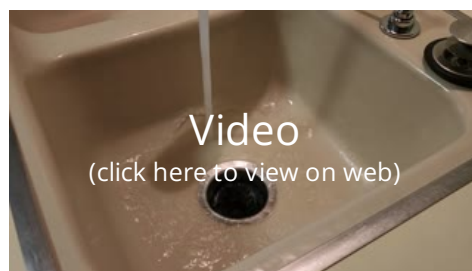
At the time of the inspection, the garbage disposal was excessively noisy. This could be as simple as removing a foreign object from the interior of the disposal. The inspector recommends having a qualified plumber evaluate and repair.

Contact a qualified plumbing contractor.

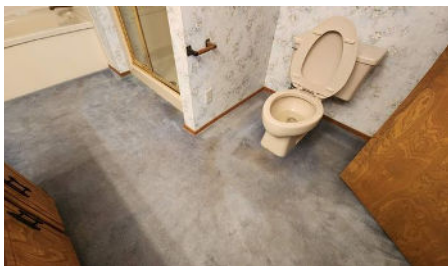
Hall bath

We noted carpet in front of a shower, bathtub or toilet in one or more bathrooms. Having carpet in these areas is not advised as it will repeatedly get wet. Mildew is possible. If this is a concern, consider having the carpet replaced with tile.

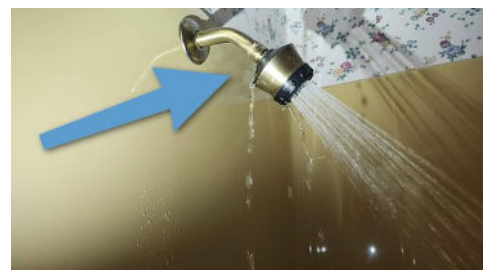
Back left bath

LEAKING SHOWER HEAD

One or more shower heads were leaking when operated. It's likely that it simply needs to be tightened or resealed. Recommend repair/replacement by a licensed plumber or handyman.

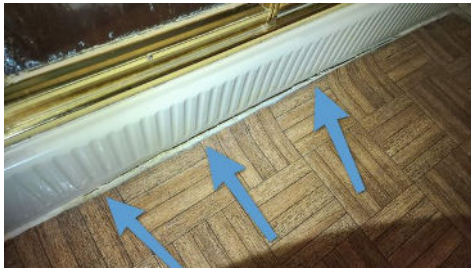
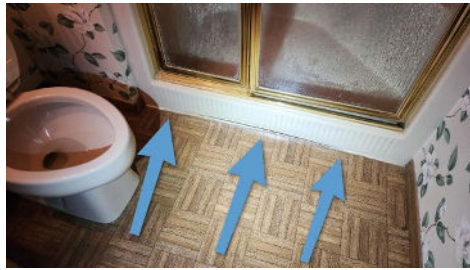
FLOORING DAMAGE OUTSIDE OF SHOWER

Moisture related damage or evidence of moisture was noted in the flooring outside of a shower. This is likely the result of water exiting the shower while in use. Recommend having the flooring repaired and ensuring the shower door/glass is properly sealed.

Moisture damage

Contact a qualified professional.

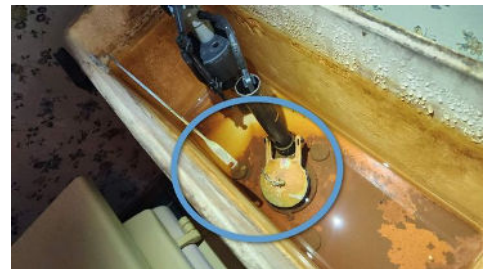
LOOSE HANDLE/CHAIN DETACHED

At the time of the inspection, one or more toilet handles were loose from it's chain and need to be reattached to ensure proper functionality.

Flush chain detached

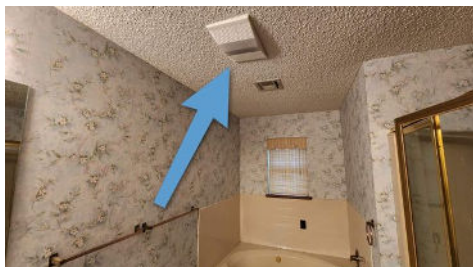
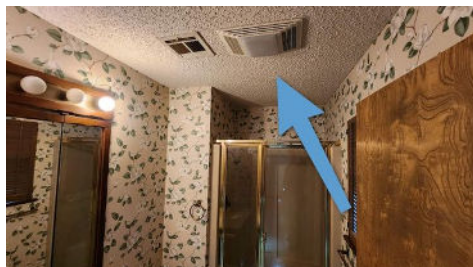
We noted a light/fan combo with an inoperable light. Recommend replacing light bulb and verify proper operation prior to closing. If replacement of the bulb doesn't correct the issue, consult an electrician for further evaluation.

Hall bath

Master bath

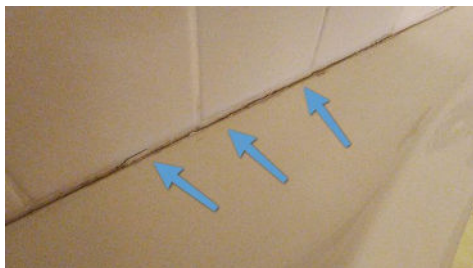
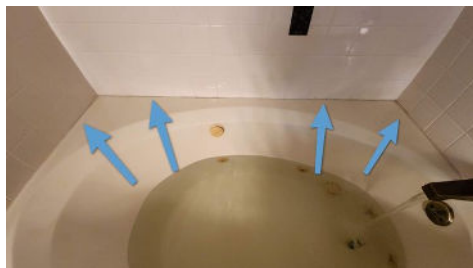
DETERIORATED GROUT/CAULK LINES

The Grout or caulk lines around the jetted tub were deteriorated at the time of the inspection. This can result in moisture intrusion under the tiles causing them to become loose. Recommend having these areas re-grouted or sealed with caulking to ensure water tightness.

Hall bath tub

Hall bath surround

Contact a qualified tile contractor

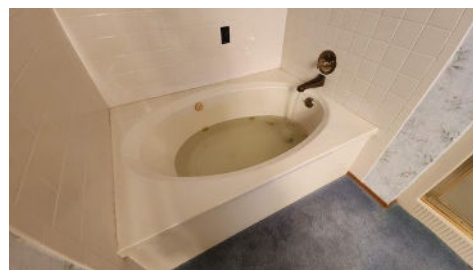
The jetted tub in the master bathroom was not GFCI protected. Although it may not have been a requirement when the home was built or tub was installed, moder standards currently requires them. Recommend having a gfci outlet installed for safety purposes.

Hall bath/needs GFCI

Contact a qualified electrical contractor.

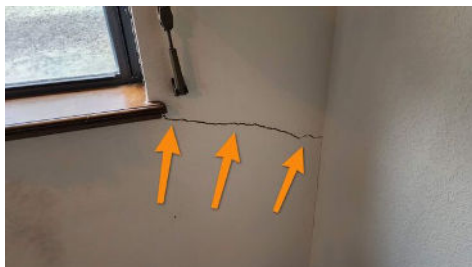
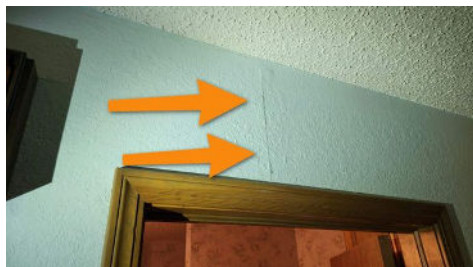
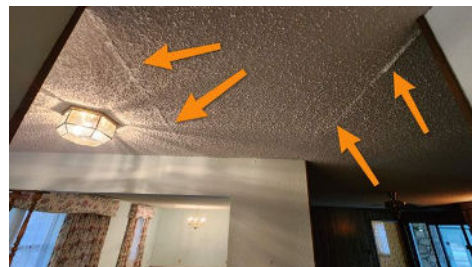
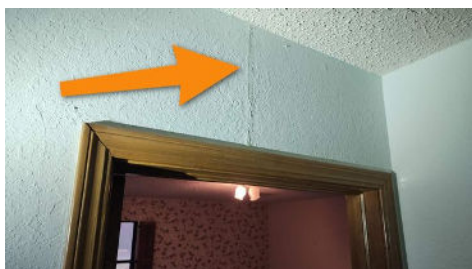
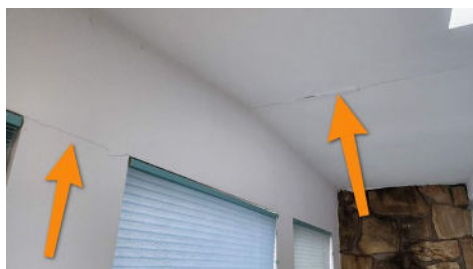
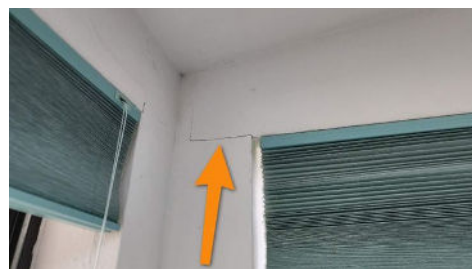
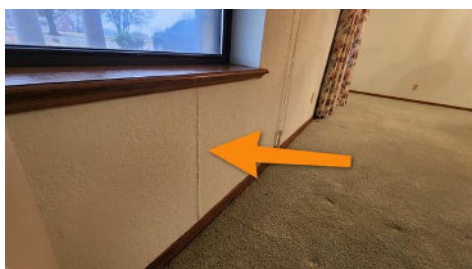
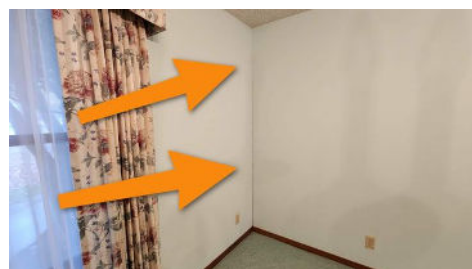
SETTLEMENT CRACKING

We noted minor cracking on the walls in one or more locations in the home. Vertical or diagonal cracks around doors and windows are common as the home naturally shifts. Drywall seam cracks and drywall tape pulling/buckling are also indicators of movement. These conditions can be attributed to long term settlement due to soil movement. Recommend monitoring or having the condition patched or repaired by a qualified professional. Minimizing moisture accumulation around the foundation is key in minimizing foundation settlement.

Back left bedroom wall

Above hall bath door

Entry/seam cracking

Hallway

Sun room

Front room

Corner of front room

Contact a qualified drywall contractor.

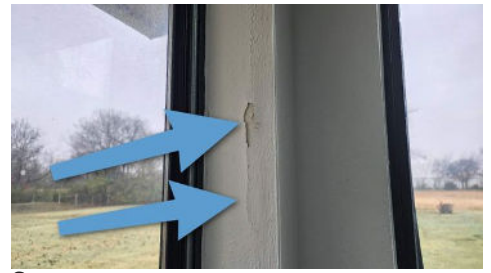
Sun room

We noted one or more areas of the interior walls that displayed peeling paint. This could be the result of moisture intrusion however, the areas was tested with moisture meter and was dry. Recommend scraping, repainting then monitoring going forward.

Contact a qualified painting contractor.

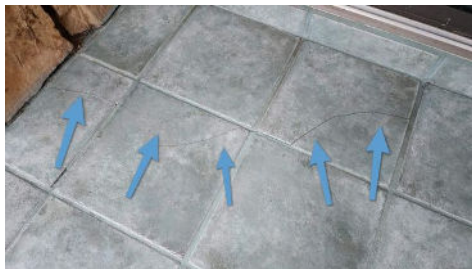
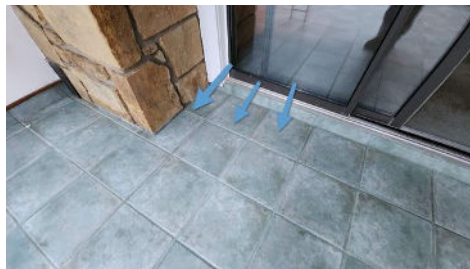
TILE CRACKED/DAMAGED

Cracked floor tile was noted in the house in one or more locations. In some cases, this can be an indication of possible foundation or subfloor shifting. The inspector recommends have the cracked/damaged tile replaced as needed.

Cracked tile

Sunroom

Contact a qualified flooring contractor

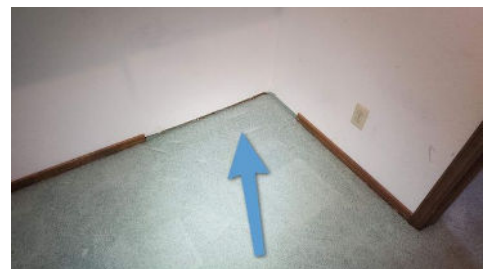
Master closet

TRIM MISSING

Trim was noted as missing in one or more areas of the floor/wall transition at the time of the inspection. Recommend having properly installed as needed.

Contact a qualified carpenter.

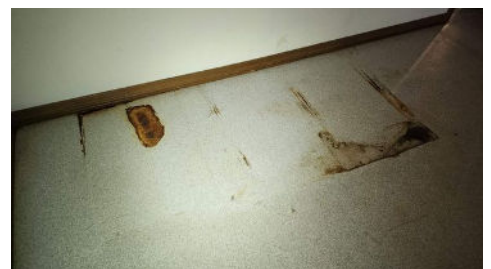
Back left bedroom

LINOLEUM FLOOR DAMAGE

We noted one or more areas of linoleum flooring that was damaged or otherwise deteriorated. Recommend repairs as needed.

Contact a qualified flooring contractor

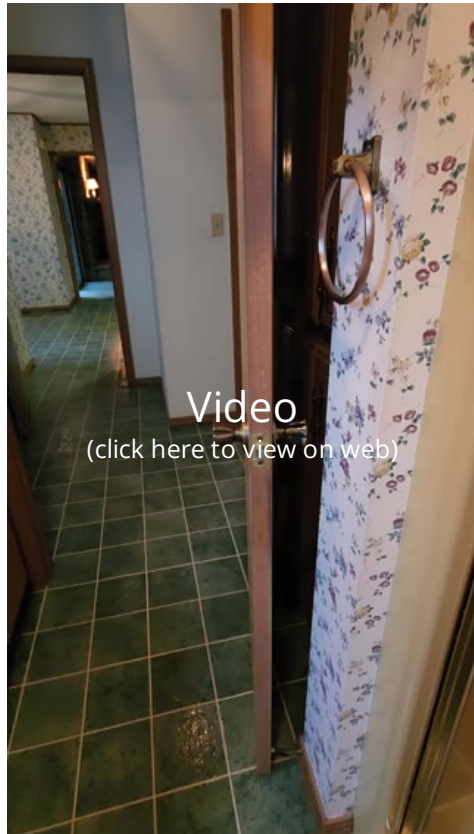
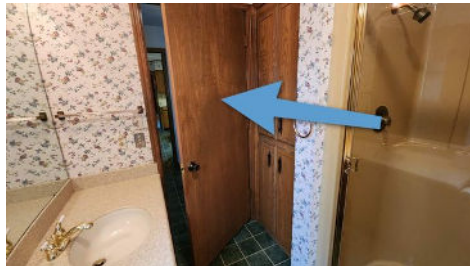
Back left hall bath entry

One or more interior doors would not stay open on it's own. This is caused by the door not being hung plumb. A simple fix is to remove the door hinge pin and hammer it on a concrete surface a few times to add a slight bend to the door pin. Reinstall the door pin. This slight bend will cause a minor bit of friction in the hinge, allowing the door to stay open. If this does not work with one hinge, keep trying on all 2-3 hinges till door stays open.

Contact a handyman or DIY project

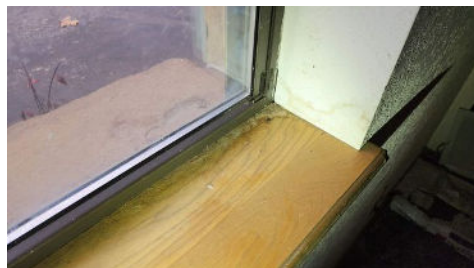
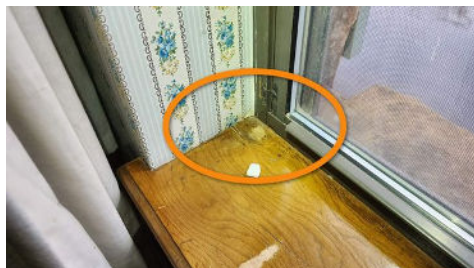
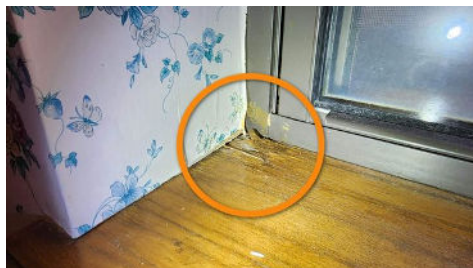
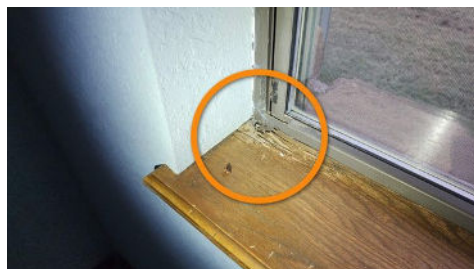
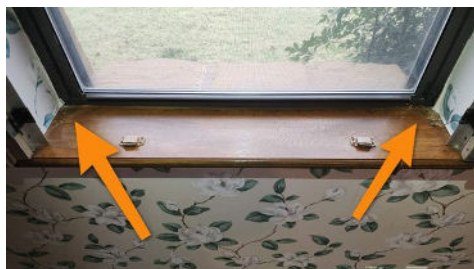
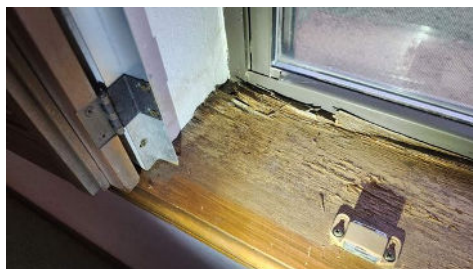
MOISTURE STAINING/DAMAGE

Moisture staining or damage was noted around one or more interior windows which indicates leaking. These windows were older and displayed missing/Deteriorated caulking in multiple locations on the exterior windows. Recommend ensuring that all windows and caulked and adequately sealed from the outside.

Room left of garage

Back left bedroom

Back left bath window

Front right bedroom

Master

Contact a qualified window repair/installation contractor.

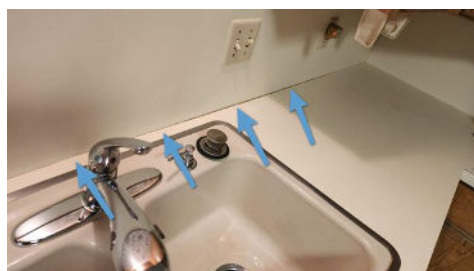
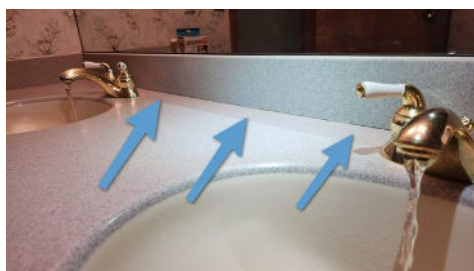
POOR/MISSING CAULK/GROUT

On or more countertops or backsplashes were missing sufficient caulk/grout/sealant at the transition. This can lead to water damage behind the cabinets in the event of splashes or spills. Recommend adding sealant at the backsplash and areas where counters touch walls.

Kitchen

Hall bath

Contact a qualified handyman.

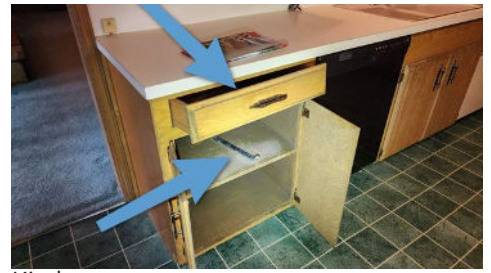
Kitchen

DAMAGED DRAWER SLIDES

We noted one or more drawer slides that were worn/damaged or loose at the time of the inspection. This causes the drawers to wobble or drop when opened. Improper install is the likely cause of the issue. Recommend having these slides repaired, replaced or installed correctly as needed.

Contact a qualified handyman.

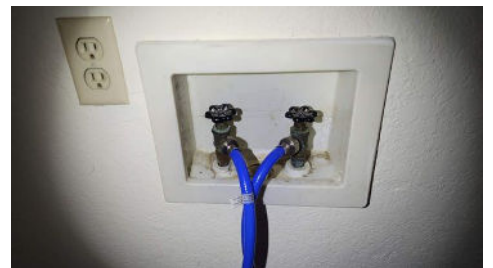
At the time of the inspection, the laundry room washer box was missing its seals, or the seals were damaged/inadequate, at the base of the water supply pipes. These seals, in the event of a leak, prevent water from running into the wall below which will damage drywall. Washer boxes must be water tight in order to properly direct any present moisture to the stand pipe drain. Recommend having this condition corrected.

Missing seals
